Test of the Vaporless Manufacturing ISM 4080 and ISM 4081

Final Report

PREPARED FOR:
Vaporless Manufacturing, Inc.

March 27, 2004

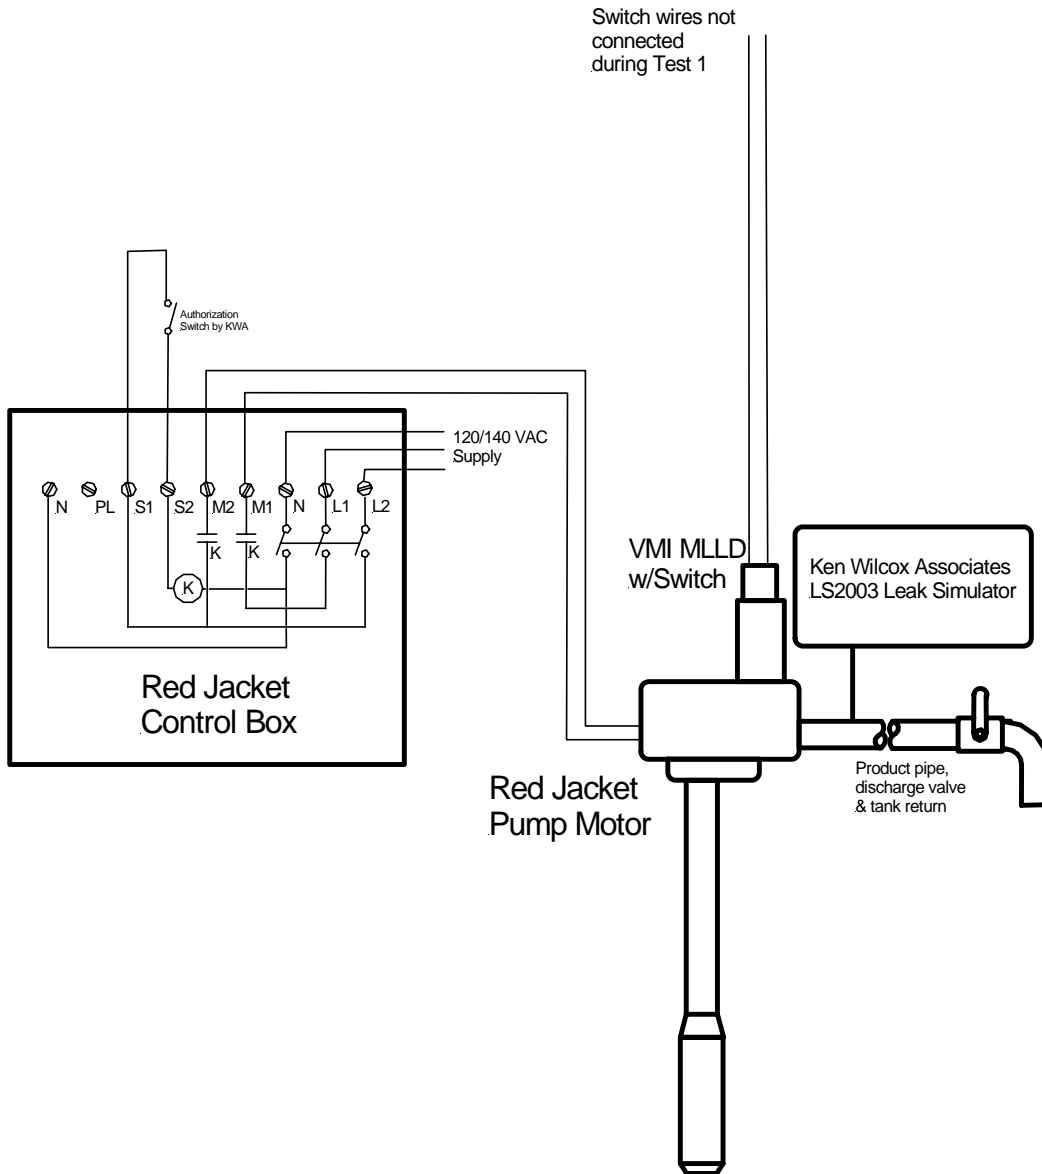
Test 1 Layout & Electrical Schematic
Vaporless Manufacturing ISM 4080 & Switch
Ken Wilcox Associates
3/24/04, WHill

Switch wires not
connected
during Test 1

1. A Vaporless MLLD with attached sensor switch was installed in the leak detector port of a Red Jacket P75S1 pumping unit per "Test 1 Layout and Electrical Schematic" attached. The switch leads were not connected.
